**HARDLOCK®**

APPLICATIONS

Self-Locking Nut

HARDLOCK Nut (HLN)

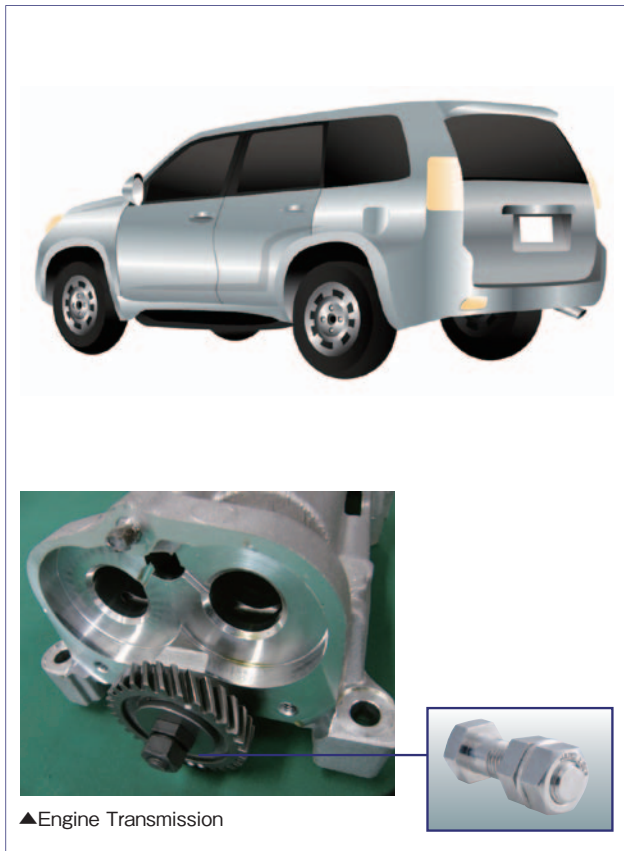
HLN SUV Engine Transmission

- Flanged Nuts were utilized in the engine transmissions of SUVs
- Loosening of nuts occurred frequently when starting the engine and many SUVs had to be recalled.

- By switching from Flanged Nuts to HARDLOCK Nuts the loosening problem was resolved.
- By utilizing HARDLOCK Nut the loosening occurring when starting the engine were also resolved.

- Loosening due to cyclic stress in the rotational direction of the bolts axis

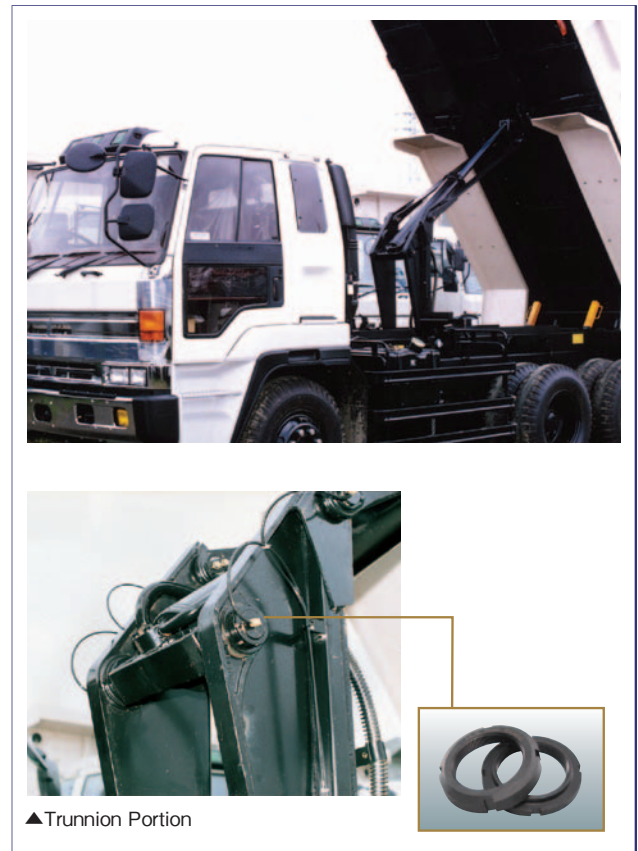
HLB Specially equipped vehicle trunnion fixing

- Double bearing nuts were used as a countermeasure for loosening
- The double bearing nuts were tightened by the "double nut method". However, loosening occurred due to the variation in tightening force.

- By adopting the HARDLOCK Bearing Nut, the workability was improved and the loosening problem was solved.
- By switching to HARDLOCK Nut, the maintenance costs were significantly reduced

- Loosening due to cyclic stress in the rotational direction of the bolt axis

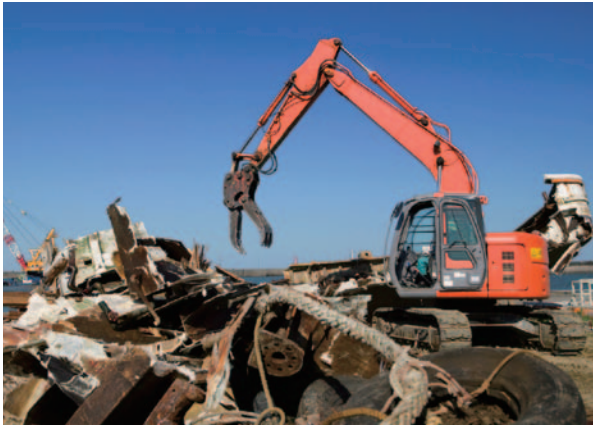
▲Hydraulic Breaker

- Loosening caused by severe impact vibration from crushing operations at mines and large quarries occurred on a regular basis. Double nuts were used and carried out a high-torque fastening and dropout prevention measures, but the problem was not solved.

- By introducing HARDLOCK Nut, axial force management by proper torque and loosening prevention was achieved

- Loosening due to cyclic stress in the direction perpendicular of the bolts axis

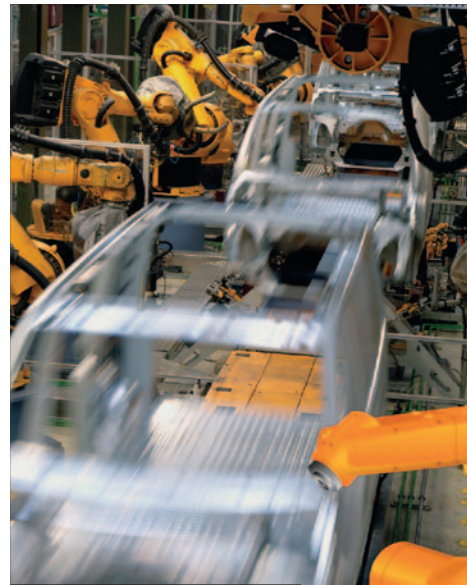
Industrial Robot▲

- Prevailing torque type self-locking nuts where used were in the arm portion, but iron powder produced by the friction between the nut and shaft caused poor movability.
- Torque control was difficult with prevailing torque type self-locking nuts and there was a problem with variety in axial force.

- By switching to HARDLOCK Bearing Nut the problem with shaft damage was resolved.
- Axial force management by proper torque combined with elimination of loosening improved the product performance of the industrial robots.

- Loosening due to cyclic stress in the rotational direction of the bolt axis

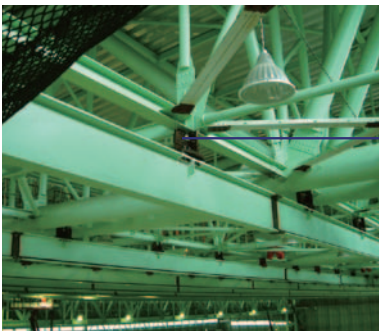
▲Rail Fastening Portion

- Prevailing torque nuts were used for indoor overhead cranes. However, due to excessive vibration loads they became loose on a regular basis.
- Due to the everyday loosening, re-tightening works etc., maintenance cost was increased immensely.

- By changing to HARDLOCK Nuts, loosening in the fastening portions of the cranes was eliminated.
- As a result, stable operations and reduction in maintenance work lead to significant cost savings.

- Loosening due to cyclic stress in the direction perpendicular of the bolt axis

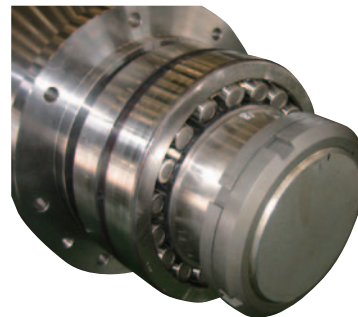
▲Mill Roll

- To prevent loosening at steelwork equipment lines, the shafts have key grooves and are fastened with both toothed washers and nuts as well as welding in some instances.
- In recent years, steelwork facilities are continuing with a fire-free work environment. Therefore, welding and such other procedures have been minimized.

- Loosening due to cyclic stress in the rotational direction of the bolt axis
- Loosening due to cyclic stress in the direction perpendicular of the bolt axis

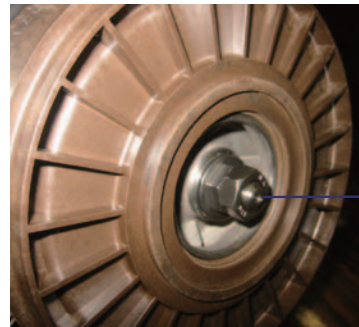
◀Impeller

- Vibration in the pump due to high speed rotation in the impeller shaft caused loosening.
- Castellated nuts and other self-locking components were used, but this did not completely resolve loosening.

- After switching to HARDLOCK Nut vibration loosening due to high speed rotation was completely eliminated, as well as significant decrease in periodic maintenance costs.
- Switching to HARDLOCK Nut also prolonged the product life.

- Loosening due to cyclic stress in the rotational direction of the bolt axis

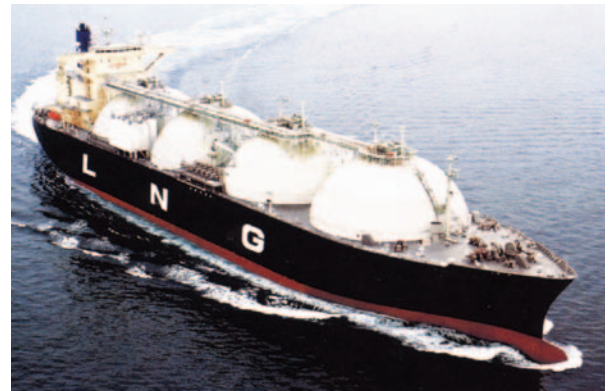
▼Ship Engine

- Double nuts were used on the internal combustion engines of the ship, loosening due to thermal expansion and severe vibration occurred on a daily basis.
- Retightening work had to be made frequently and an enormous amount of time and cost was spent on maintenance.

- By switching to HARDLOCK Nut with special coating, Loosening due to vibration and/or thermal expansion was eliminated.
- Significant reduction in maintenance cost as well as retightening work.

- Loosening due to micro-motion abrasion
- Loosening due to cyclic stress in the direction perpendicular to the bolt axis
- Loosening due to thermal expansion

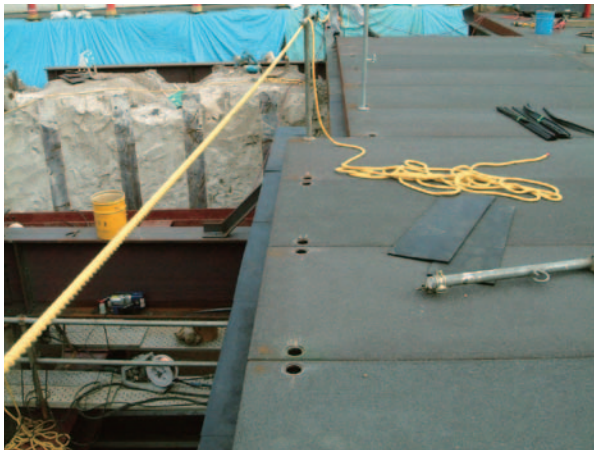
▲Road Plates

- Countermeasures such as welding and insertion of cushioning materials to reduce vibration in the road plates were carried out. However, due to poor welding and replacement of cushioning material work, both options were unsatisfactory.
- Another serious problem was the noise control due to collision of the road plates when vehicles passed over them.

- By switching to HARDLOCK Nut in the connection portion of the road plates, problems such as loosening were eliminated.
- Additionally, the noise generated when vehicles pass over the road plates was eliminated and overall costs were reduced.

- Loosening due to cyclic stress in the direction perpendicular to the bolt axis

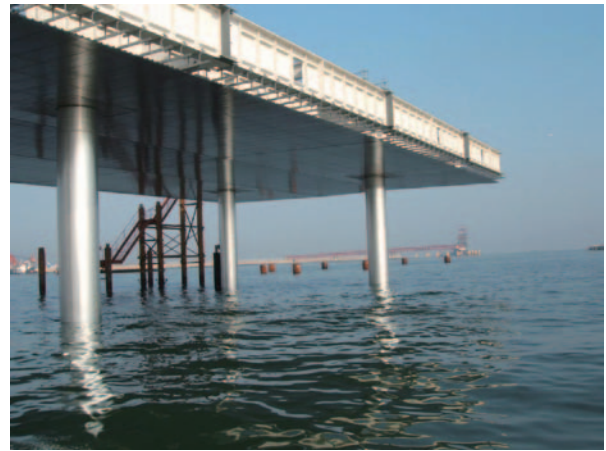
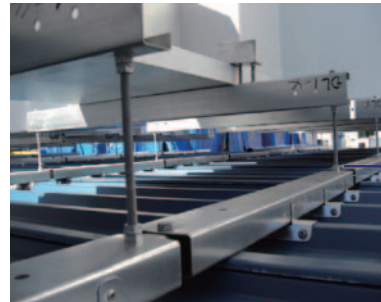
◀Pier Cover Plate Mounting

- During the construction of the titanium panel on artificial grounds rear surface of the offshore airport, prevailing torque self-locking nuts were studied.
- Since the prevailing torque type self-locking nuts caused scratches on the bolt (peeling off the plating), rust occurrence was a serious problem and concerns regarding safety and corrosion resistance arose.

- By switching from prevailing torque type self-locking nuts to HARDLOCK Nuts, problems related to bolt damage and corrosion were eliminated.
- Loosening due to severe vibration in the pier cover plates during landing and take-off of aircrafts were eliminated, HARDLOCK Nut also corresponded to the 100 year warranty requested by the Ministry of Land, Infrastructure and Transport.

- Loosening due to micro-motion abrasion
- Loosening due to cyclic stress in the direction of the bolt axis

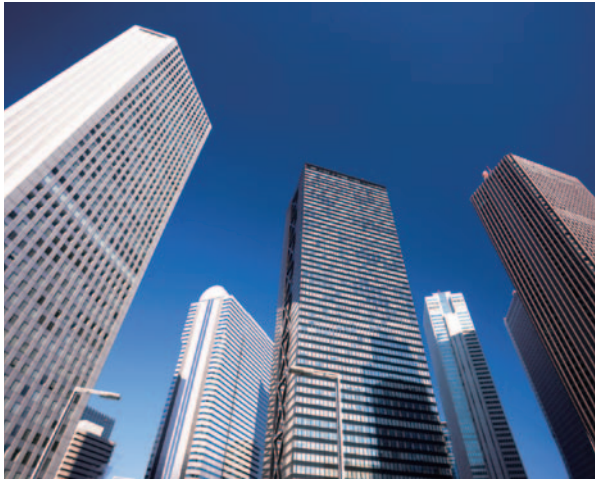
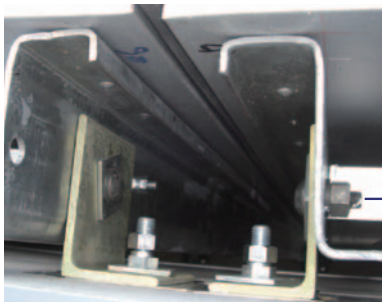
◀ Exterior Wall Mounting

- Aluminum curtain walls were mounted on the exterior walls of high-rise buildings with metallic fasteners, but due to the high torque required to tighten the metallic fasteners, it caused expansion of the aluminum which would cause a specific sound.

- Loosening due to cyclic stress in the direction perpendicular to the bolts axis
- Loosening due to thermal causes

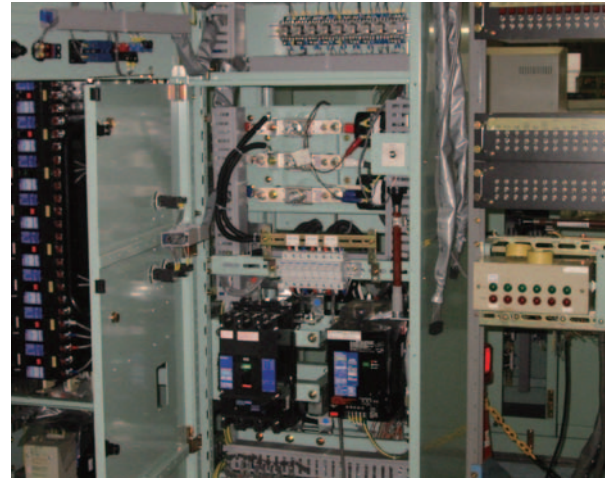
◀ Distribution Boards

- Double nuts or spring washer were used, loosening due to vibration caused during product transportation was a regular occurrence.
- Loosening after installation due to micro-vibration during operation occurred on a daily basis.

- By switching to HARDLOCK Nut, due to proper torque control, loosening during transportation and/or operation was eliminated.
- Significant savings in labor was achieved due to eliminating re-tightening work.

- Loosening due to micro-motion abrasion

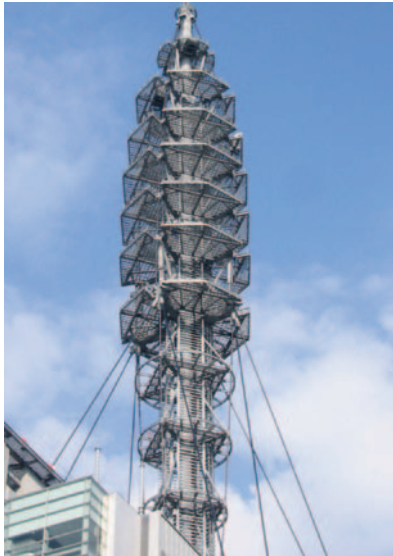
Connecting Portion ▶

- Other self-locking double nuts were used in the connection portion in communication towers, however, due to loads generated by wind and vibration that occurs on a daily basis, the axial force was lowered and loosening occurred.
- Re-tightening work from maintenance personal and routine maintenance cost was required to be reduced.

- Loosening due to cyclic stress in the direction perpendicular to the bolt axis
- Loosening due to cyclic stress in the rotational direction of the bolt axis
- Loosening due to excessive external force

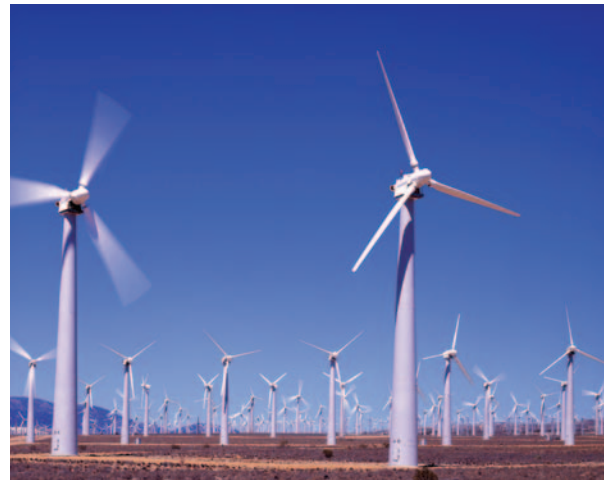
Cable Rack in Turbine Towers ▶

- Wind turbine towers are installed in areas where there are strong winds, due to the irregular stress induced by strong winds, common double nuts and/or spring washers were not able to produce significant locking effect and eliminate loosening.
- Nylon nuts were used in the fastening portions of wiring cable racks, ladders etc. inside of wind turbine towers, however, due to the vibration caused by the rotation of the blades (wings) the Nylon nuts became loose on a regular basis.

- By switching to HARDLOCK Nut, due to successful axial force control and proper torque, loosening was eliminated.
- Regular maintenance work and equipment maintenance cost was significantly reduced.

- Loosening due to cyclic stress in the direction perpendicular to the bolt axis
- Loosening due to micro-motion abrasion

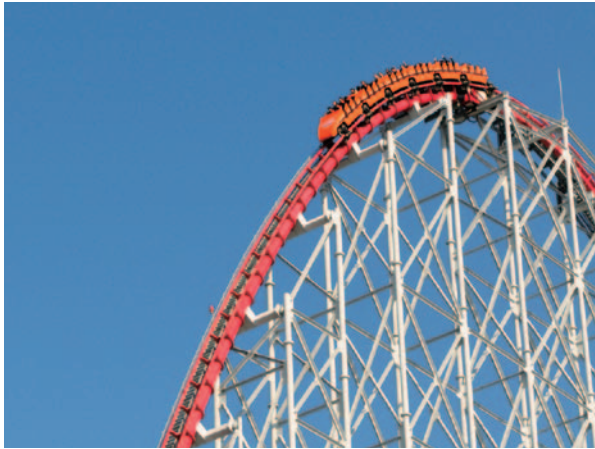
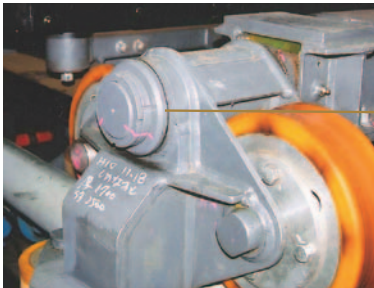
▲Guide Roller Portion

- Loosening due to cyclic stress in the rotational direction of the bolt axis
- Loosening due to cyclic stress in the direction of the bolt axis

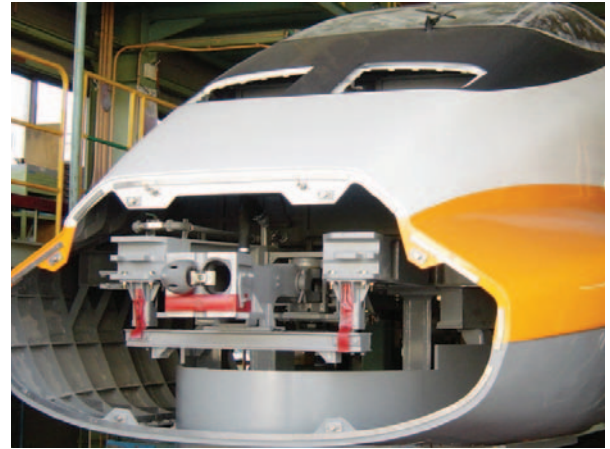
▼Shinkansen Tight Coupler

- In high speed rail cars, repeated impact of the rail coupling causes the nut to loosen and may even risk detachment. Damage to the friction ring also causes the nut to loosen.

- By using the HARDLOCK Nut, even under repeated impact, loosening is prevented and detachment does not occur. Breakage of the friction ring is eliminated by using the HARDLOCK Nut and has been adopted by many rail car manufacturers.

- Loosening due to cyclic stress in the direction of the bolt axis
- Loosening due to cyclic stress in the direction perpendicular of the bolt axis

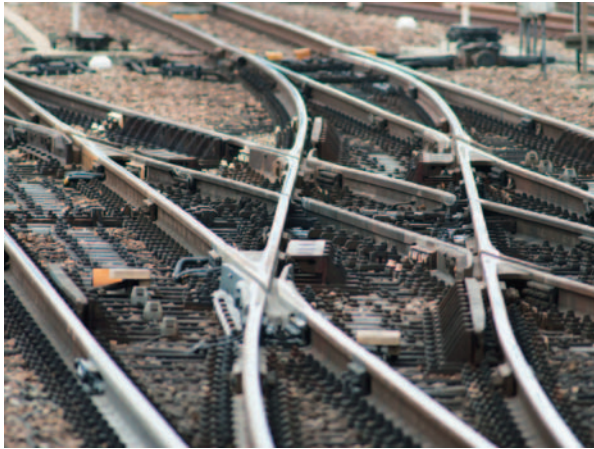
▲Railroad Switch

- When a train passes, a force of 500G is applied to the switch, and even specially shaped double nuts used on the movable parts can become loose on a daily basis.
- While the switch (movable part) is essential to maintain the track gauge, it is extremely difficult to maintain the gauge of the track while preventing loosening.

- By using the HARDLOCK Nut, the maintenance cost associated with inspection and re-tightening was successfully reduced.
- The HARDLOCK Nut successfully maintained the gauge of the track and prevents loosening simultaneously. As a result, the HARDLOCK Nut has been adopted by all railway companies in Japan.

- Loosening due to cyclic stress in the direction of the bolt axis
- Loosening due to cyclic stress in the direction perpendicular of the bolt axis

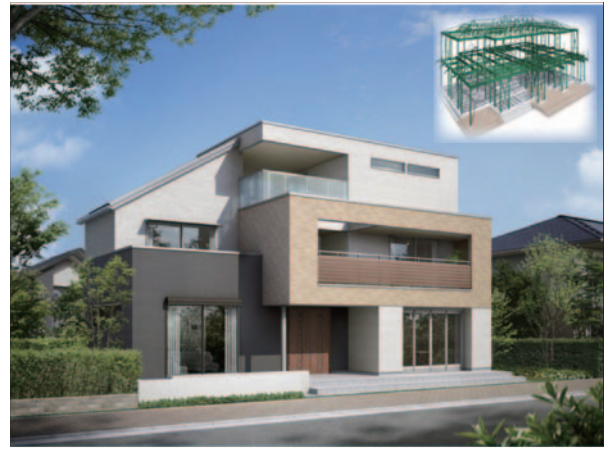
▲Steel Frame joint

- Conventionally, based on the Building Standards Law, Single Nuts and Spring Washers was going to be used in the Light-gauge Steel Joint as a countermeasure for loosening.

- Loosening due to cyclic stress in the direction of the bolt axis
- Loosening due to cyclic stress in the direction perpendicular of the bolt axis

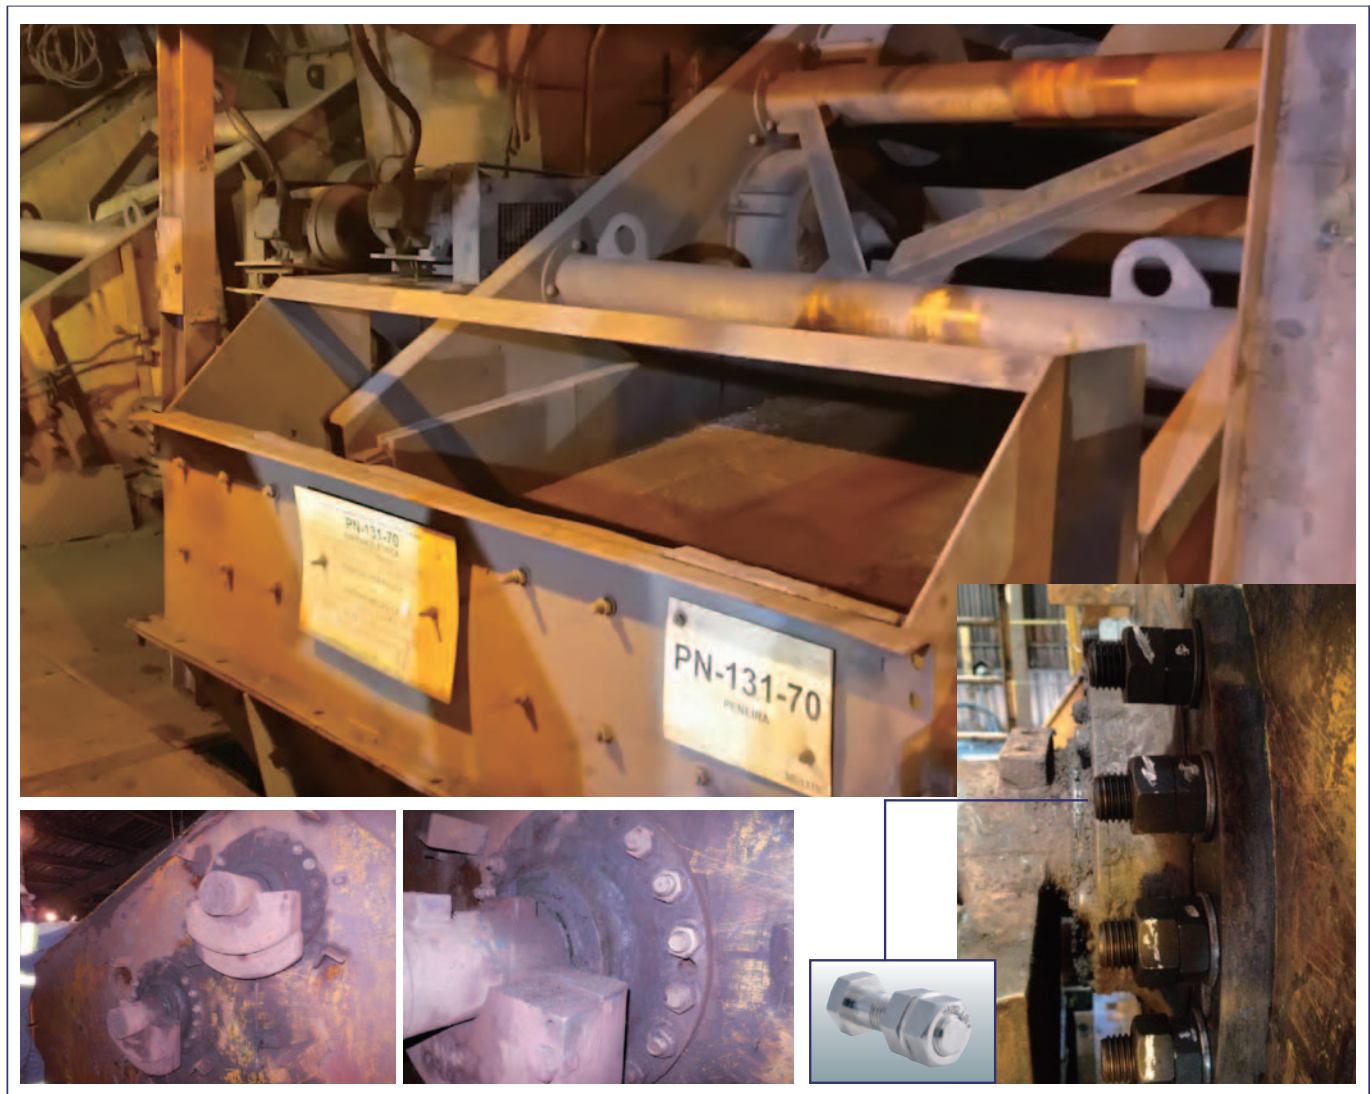
Pendulum Fastening for Vibration Screens

- Loosening due to cyclic stress in the direction perpendicular of the bolts axis
